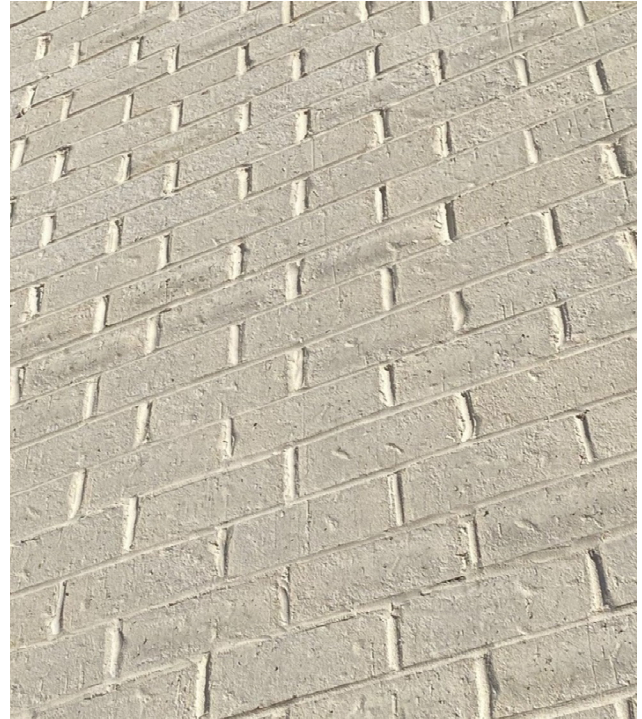
Bloating is a process that is relatively common in the production of clay brick. This is a result of carbon hearts formed in the firing process in the kiln. During vitrification, or glass formation of materials, the brick begins to seal itself. This can trap gases forming within the brick, and sometimes cause the face of the brick to bulge slightly.

While bloating can affect the appearance of the brick, it in no way affects the durability or structural performance of the brick. These brick are actually stronger and more durable than other brick because the carbonaceous materials, which are formed, are typically harder and denser than a normal brick body. In fact, black coring used to be intentionally induced in clay sewer pipe manufacturing to improve the compressive and tensile strength.

Photo 1: Bloating

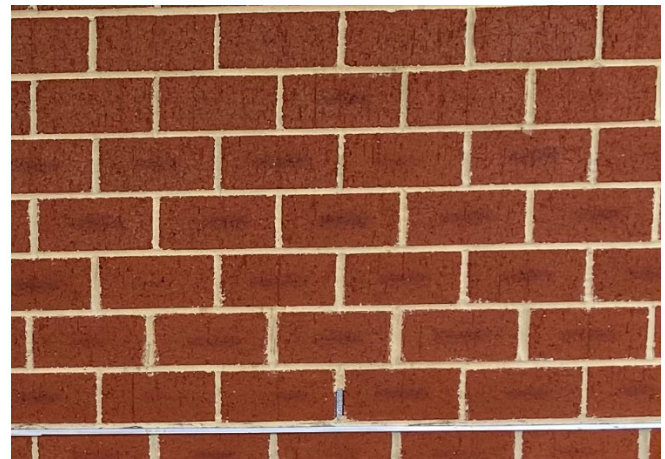
The phenomenon is influenced by gas conditions in the kiln which prevent some of the carbon in the material from burning completely. Therefore “black cores” or “black hearts” may also sometimes be present in the body of the brick or visible on the face. Additional names for the this include “black spots” “carbon spots” and “carbon hearts”.

Photo 2: Carbon Spots
