Technical Bulletin – Header Coverage

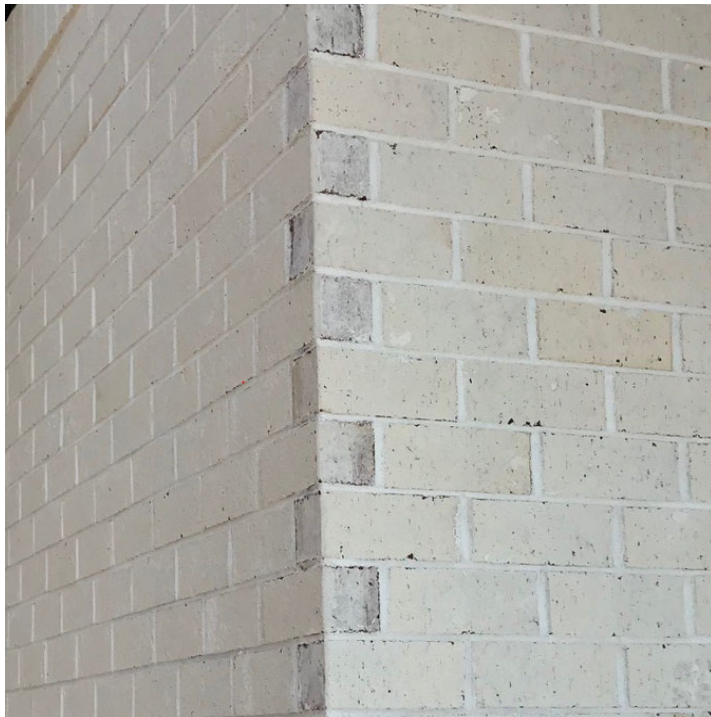
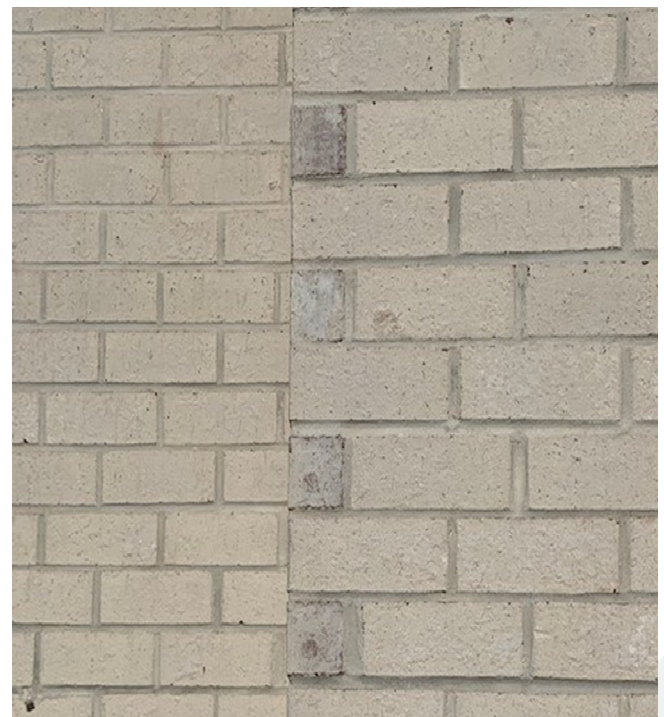
Achieving uniform header coverage is something that can prove difficult in brick production. This has become even more true with the popularity of white brick. As the use of white brick has grown, there has been an increase in customers experiencing dissatisfaction with header coverage. This is due in large part to the contrast between red and brown brick bodies and white coatings. While it is our goal to produce brick with full coverage on each header all the time, it is something that is extremely difficult to achieve.

With added care and effort while brick are being laid, the number of poorly covered headers exposed on the face of the wall can be minimized or eliminated. Inspecting brick prior to laying them is something that should be conducted routinely. Brick with good headers should be identified and set aside for use at corners and openings. Additionally, most brick will have at least one good header, and this is the one that should be visible in the wall. Good masonry practices can eliminate most of the header issues that are brought to our attention. General Shale will not pay for the services of a professional stain contractor to address poor header coverage. Stain can be ordered by the quart if desired. We are very proud of our products, and always strive to provide the very best for our customers. If you have additional questions or concerns, please reach out to your General Shale sales representative.
