Technical Bulletin – Vanadium Staining

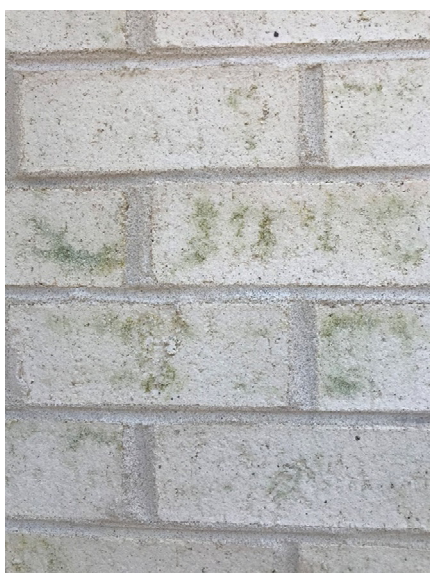
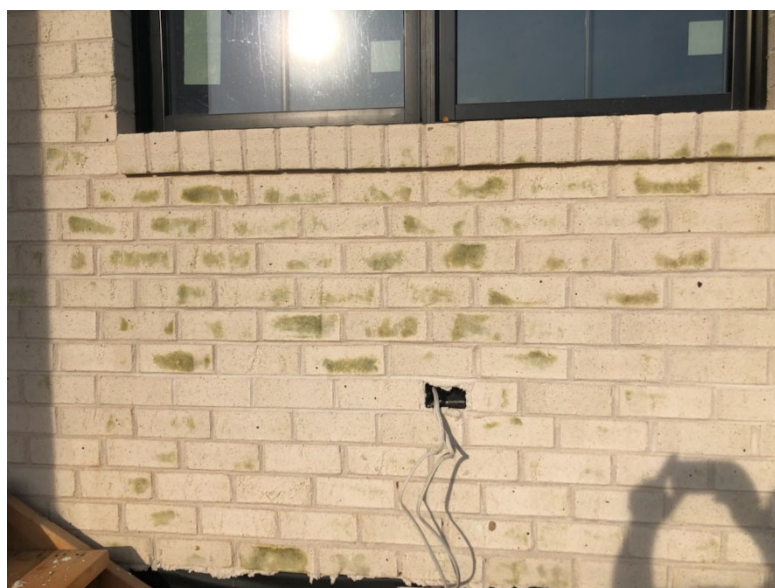
Vanadium stains are evident by a yellow- green discoloration on the face of a brick resulting from vanadium salts which are naturally present in most clays used to produce light colored bricks. Such as our Diamond White from our CCP Plant.

Vanadium stains are a result of water-soluble vanadium salts. These salts are put into solution by excess water migrating through the bricks and brought to the surface as they dry out. During this drying out process the water evaporates leaving vanadium salts on the brick surface. The vanadium salt turns green when it crystallizes in an acidic environment, such as after acid cleaning or exposure to rainwater which is naturally acidic. Vanadium stains occur in a manner very similar to efflorescence,

To prevent this staining, it is recommended to protect wall cavities during construction and keep brick cubes dry. There are also proprietary chemical cleaners that help minimize vanadium staining from occurring. Never use or permit the use of highly-concentrated, unbuffered hydrochloric (muriatic) acid solutions to clean light-colored brick

Once Vanadium staining has occurred there are proprietary cleaners such as *One Restore* by Eaco Chem which will readily and easily remove the stain. This stain removal process does not require an overall re-cleaning but can be done on a spot cleaning basis. After removing the stains they typically will not reoccur as long as there is not any excessive water migration into the wall.
