ARRISCRAFT-CADD		DETAIL No: SS08RAT
Building Stone · Brick · Limestone			TITLE: BULLNOSE WINDOW SILL		U021
DATE DRAWN: 03/02/15	SCALE: 3"=1'-0"	DRAWN BY: TRI

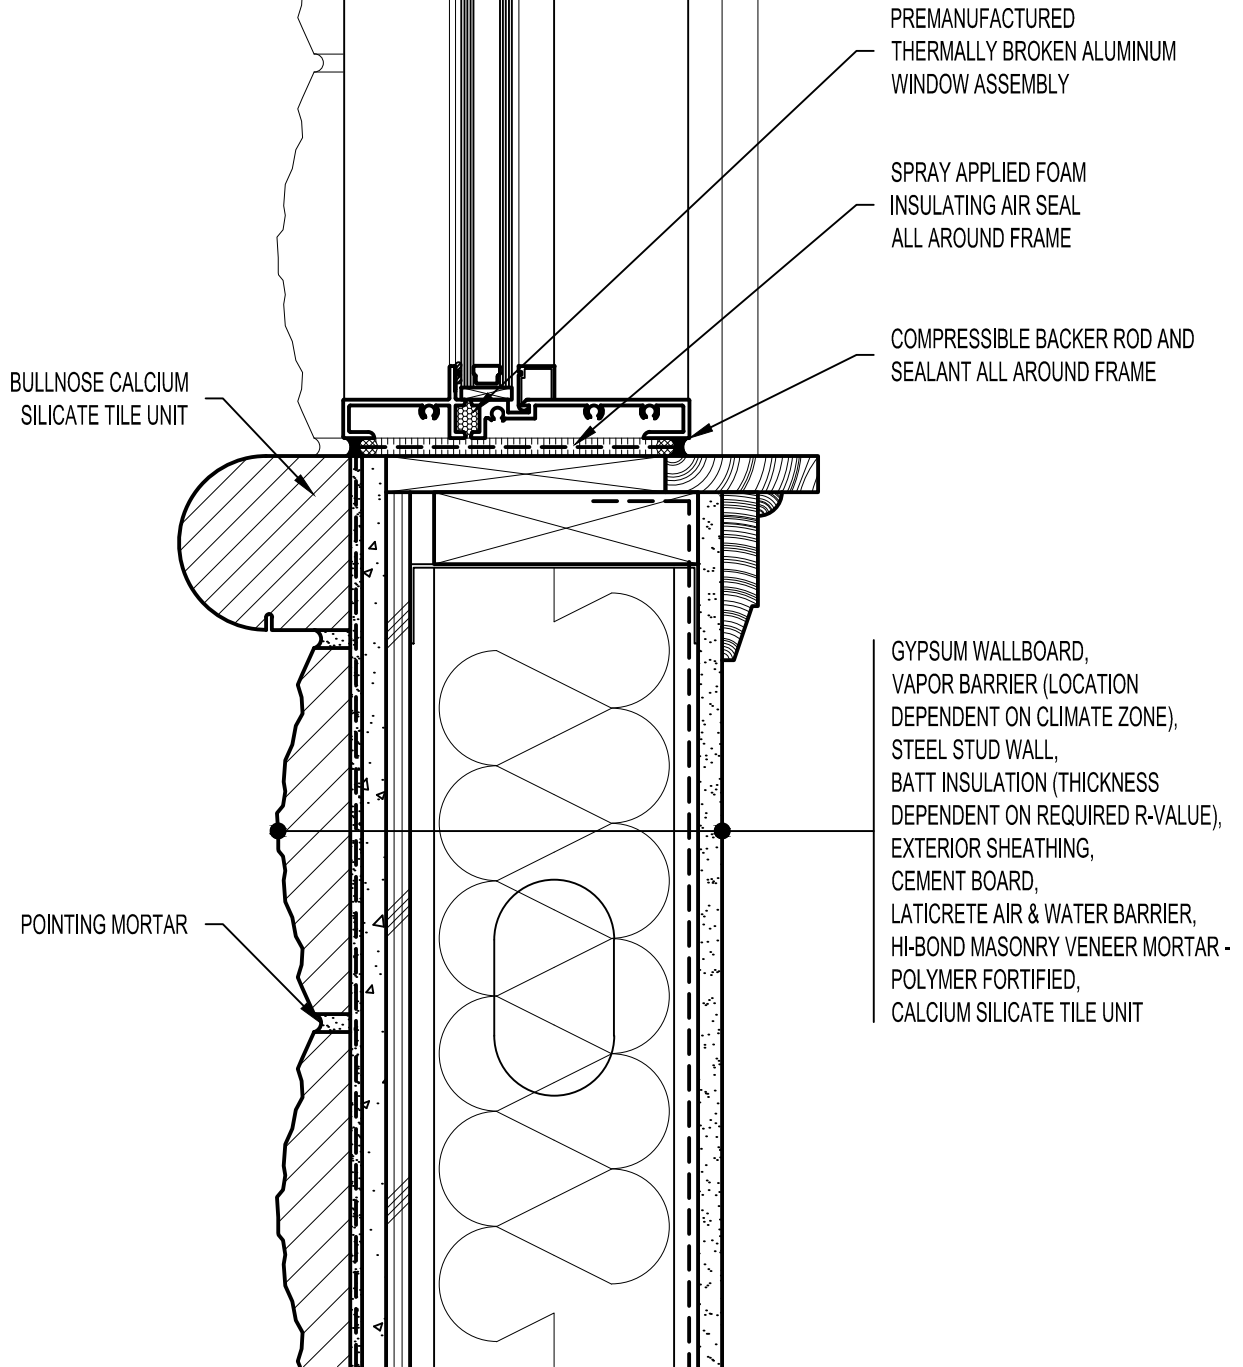
PREMANUFACTURED
 THERMALLY BROKEN ALUMINUM
 WINDOW ASSEMBLY

SPRAY APPLIED FOAM
 INSULATING AIR SEAL
 ALL AROUND FRAME

COMPRESSIBLE BACKER ROD AND
 SEALANT ALL AROUND FRAME

BULLNOSE CALCIUM
 SILICATE TILE UNIT

GYPSUM WALLBOARD,
 VAPOR BARRIER (LOCATION
 DEPENDENT ON CLIMATE ZONE),
 STEEL STUD WALL,
 BATT INSULATION (THICKNESS
 DEPENDENT ON REQUIRED R-VALUE),
 EXTERIOR SHEATHING,
 CEMENT BOARD,
 LATICRETE AIR & WATER BARRIER,
 HI-BOND MASONRY VENEER MORTAR -
 POLYMER FORTIFIED,
 CALCIUM SILICATE TILE UNIT

POINTING MORTAR

NOTE: REFER TO
 WINDOW HEAD: SS08RATU030
 WINDOW JAMB: SS08RATU041
