**ARRISCRAFT-CADD**

DETAIL No:  
 SS08RAT

TITLE:  
 BULLNOSE WINDOW SILL -  
 RECESSED WINDOW

**U024**

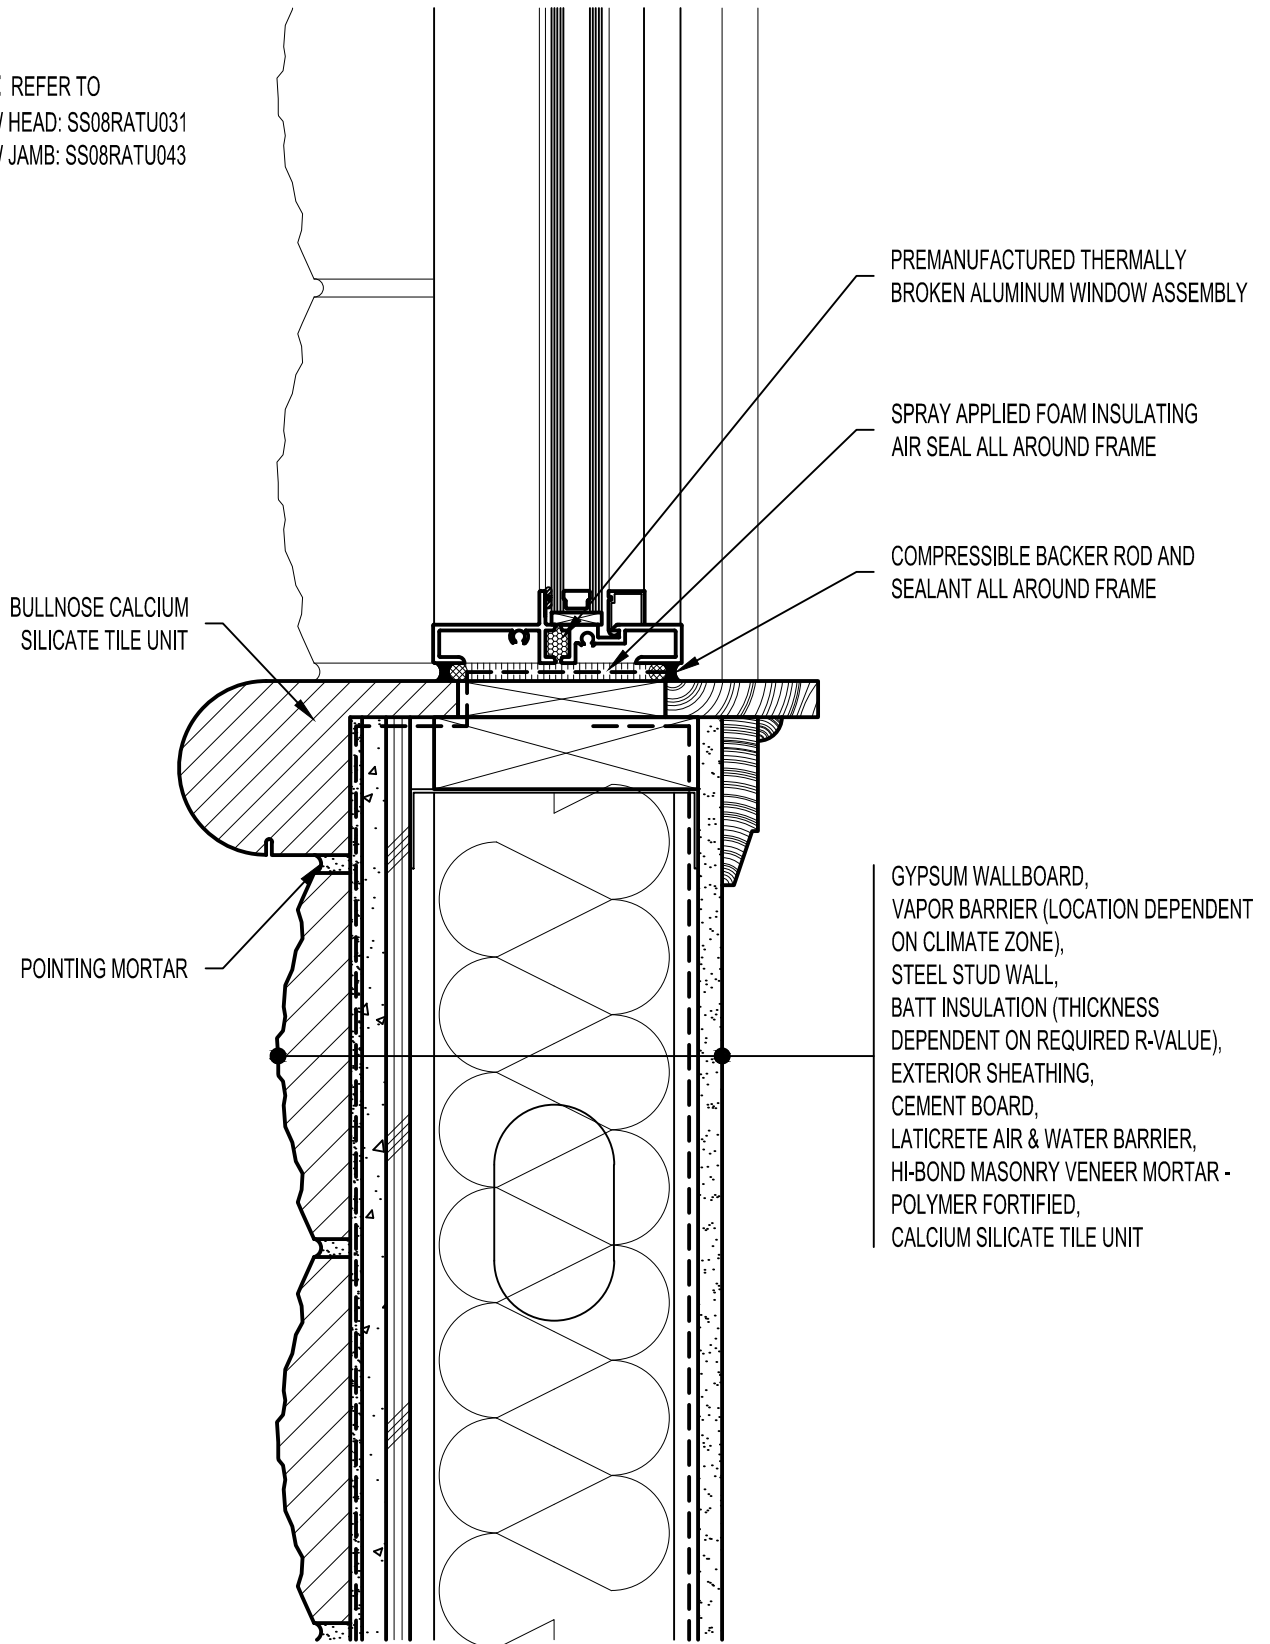
PREMANUFACTURED THERMALLY  
 BROKEN ALUMINUM WINDOW ASSEMBLY

SPRAY APPLIED FOAM INSULATING  
 AIR SEAL ALL AROUND FRAME

COMPRESSIBLE BACKER ROD AND  
 SEALANT ALL AROUND FRAME

BULLNOSE CALCIUM  
 SILICATE TILE UNIT

POINTING MORTAR

GYPSUM WALLBOARD,  
 VAPOR BARRIER (LOCATION DEPENDENT  
 ON CLIMATE ZONE),  
 STEEL STUD WALL,  
 BATT INSULATION (THICKNESS  
 DEPENDENT ON REQUIRED R-VALUE),  
 EXTERIOR SHEATHING,  
 CEMENT BOARD,  
 LATICRETE AIR & WATER BARRIER,  
 HI-BOND MASONRY VENEER MORTAR -  
 POLYMER FORTIFIED,  
 CALCIUM SILICATE TILE UNIT
