Arriscraft
 Building Stone · Brick · Limestone

DETAIL No:
 SS08SAT

TITLE:
 BULLNOSE WINDOW SILL -
 RECESSED WINDOW

U024

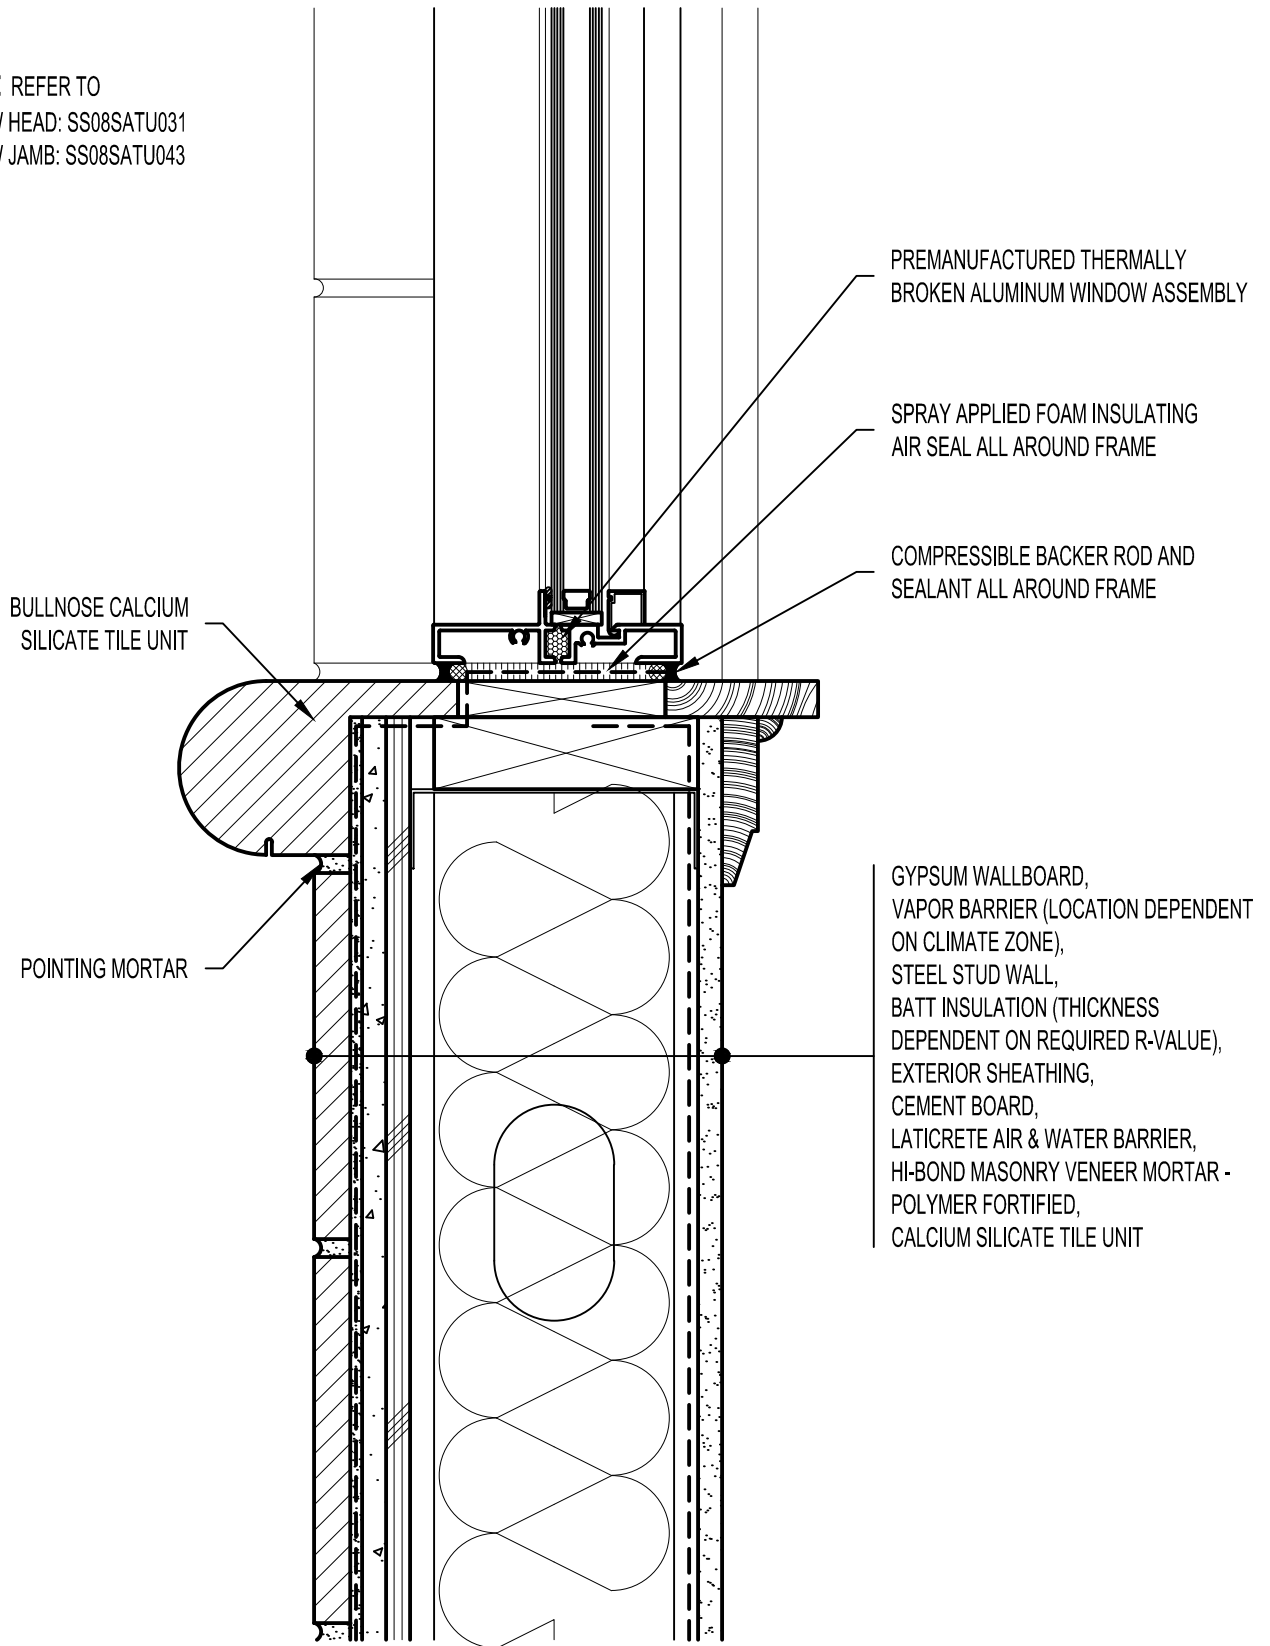
PREMANUFACTURED THERMALLY
 BROKEN ALUMINUM WINDOW ASSEMBLY

SPRAY APPLIED FOAM INSULATING
 AIR SEAL ALL AROUND FRAME

COMPRESSIBLE BACKER ROD AND
 SEALANT ALL AROUND FRAME

BULLNOSE CALCIUM
 SILICATE TILE UNIT

POINTING MORTAR

GYPSUM WALLBOARD,
 VAPOR BARRIER (LOCATION DEPENDENT
 ON CLIMATE ZONE),
 STEEL STUD WALL,
 BATT INSULATION (THICKNESS
 DEPENDENT ON REQUIRED R-VALUE),
 EXTERIOR SHEATHING,
 CEMENT BOARD,
 LATICRETE AIR & WATER BARRIER,
 HI-BOND MASONRY VENEER MORTAR -
 POLYMER FORTIFIED,
 CALCIUM SILICATE TILE UNIT

NOTE: REFER TO
 WINDOW HEAD: SS08SATU031
 WINDOW JAMB: SS08SATU043
